**State Farm Insurance Fire Loss Investigation
Origin and Cause Summary**

Insured: CRAFTON MOORE

Loss Location: 3543 N. 13th Street, Milwaukee, WI

Report Date: April 17, 2017

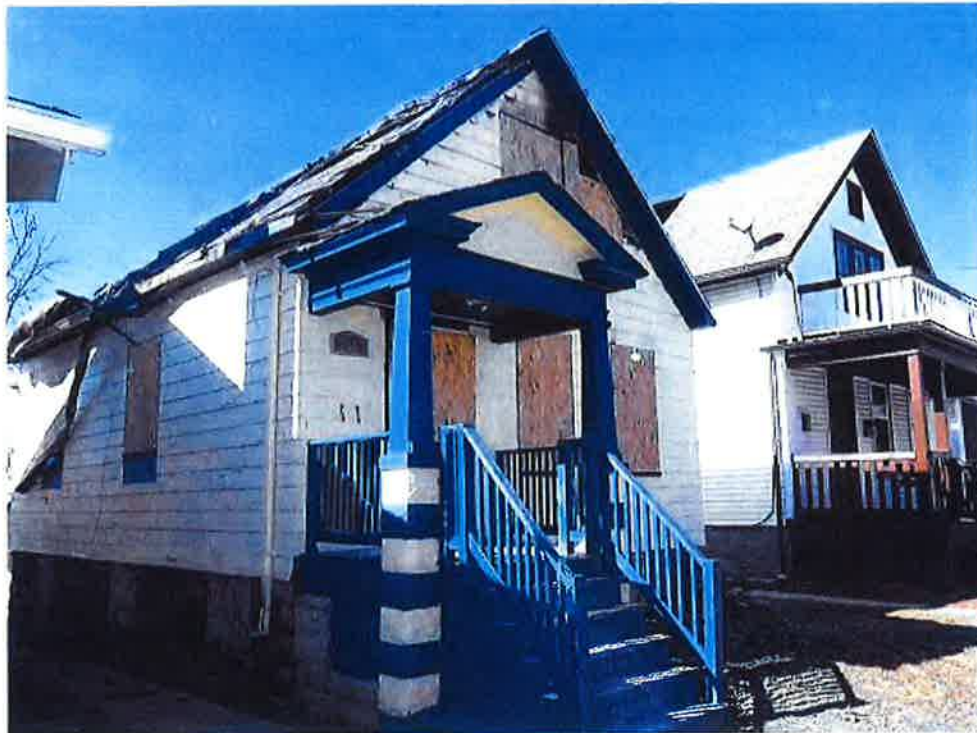
On Saturday, March 4, 2017, at approximately 5:40 AM, the Milwaukee Fire Department (MFD) received 911 calls reporting smoke coming from a residence at 3543 N. 13th Street, Milwaukee. MFD responded and forced entry to the vacant residence through the back door. MFD extinguished fire burning near the top of the back door, a living room wall and kitchen wall and eventually found additional fire burning on the second floor level. The fire caused significant damage to the residence.

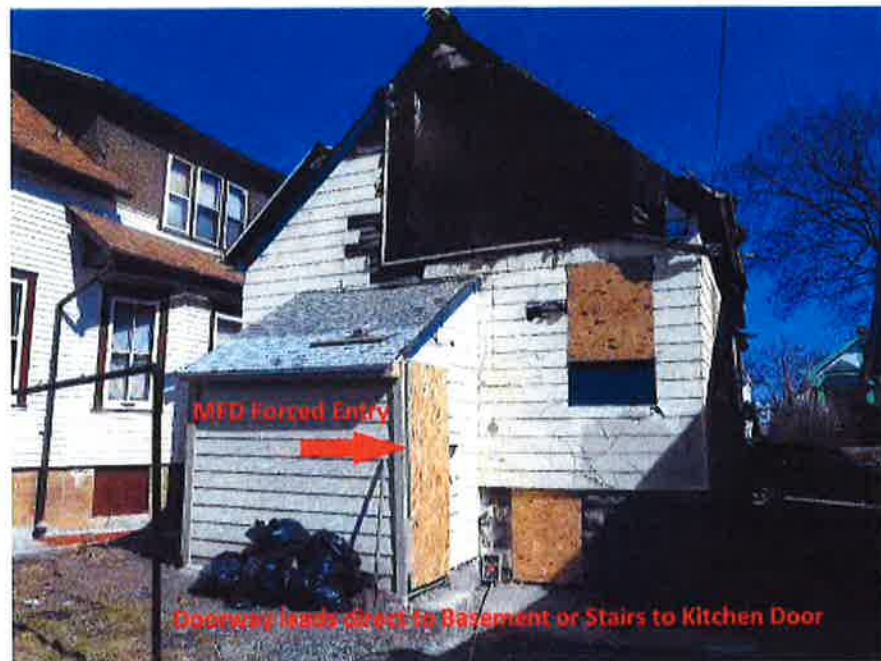
MFD Incident Report 1351970 reports that on March 4, 2017, at 5:39 AM, MFD was notified of a fire at 3543 N. 13th Street. MFD Engine 30 was first to arrive and discovered heavy smoke coming from the back of the residence. Engine 30 personnel forced entry into the residence through an exterior door.

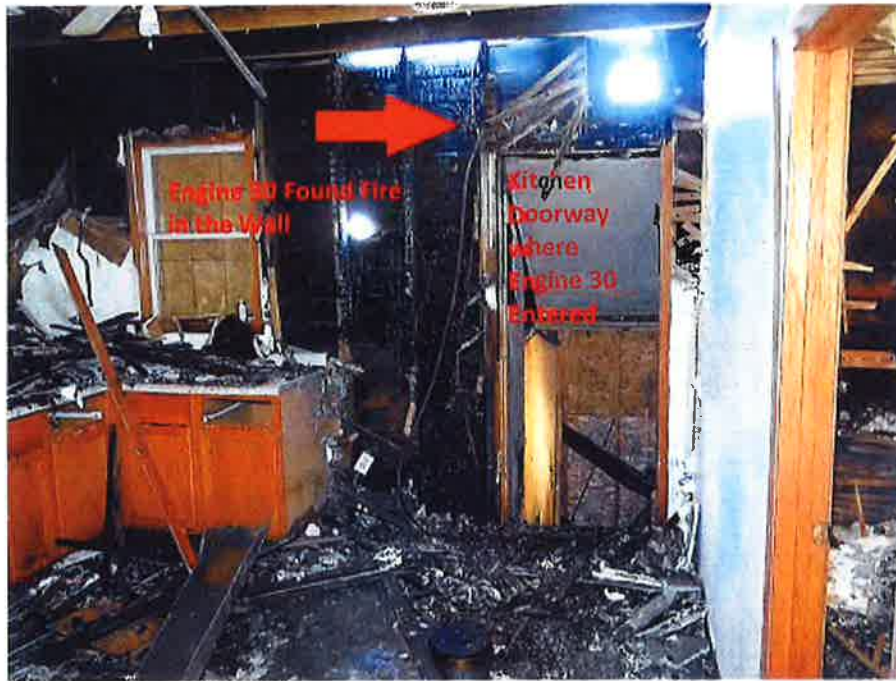
Engine 30 personnel investigated the basement of the residence but did not find any fire. Engine 30 personnel noted smoldering at the top of the interior entry door that leads into the kitchen. Engine 30 personnel entered the kitchen and "popped a hole" in the kitchen wall next to the door where they found fire and were able to immediately extinguish.

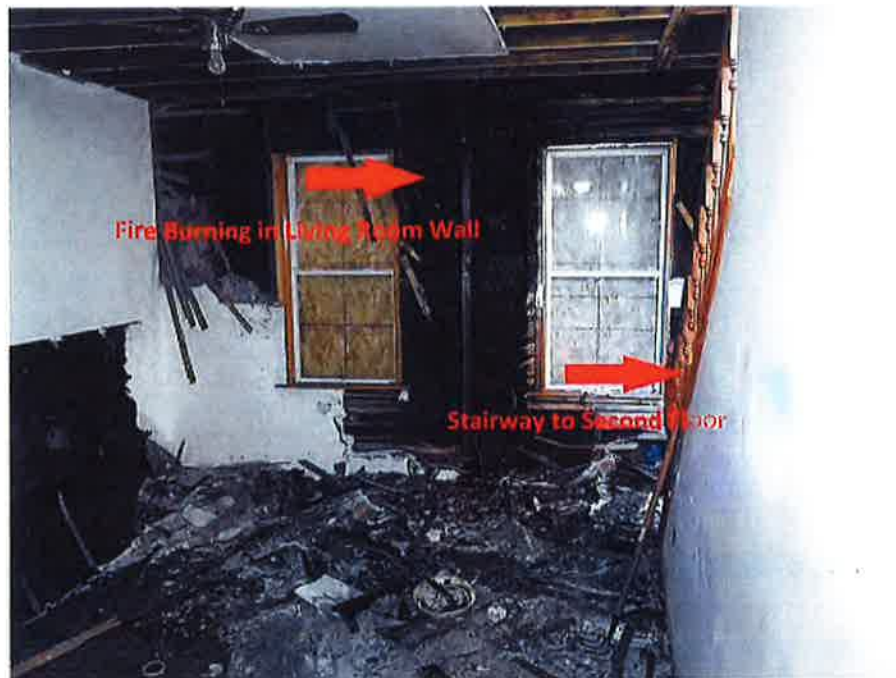
Engine 30 personnel went to the second floor where they found heavy smoke and light heat but did not immediately see fire. Engine 30 returned to the first floor where they found fire now burning in a living room wall.

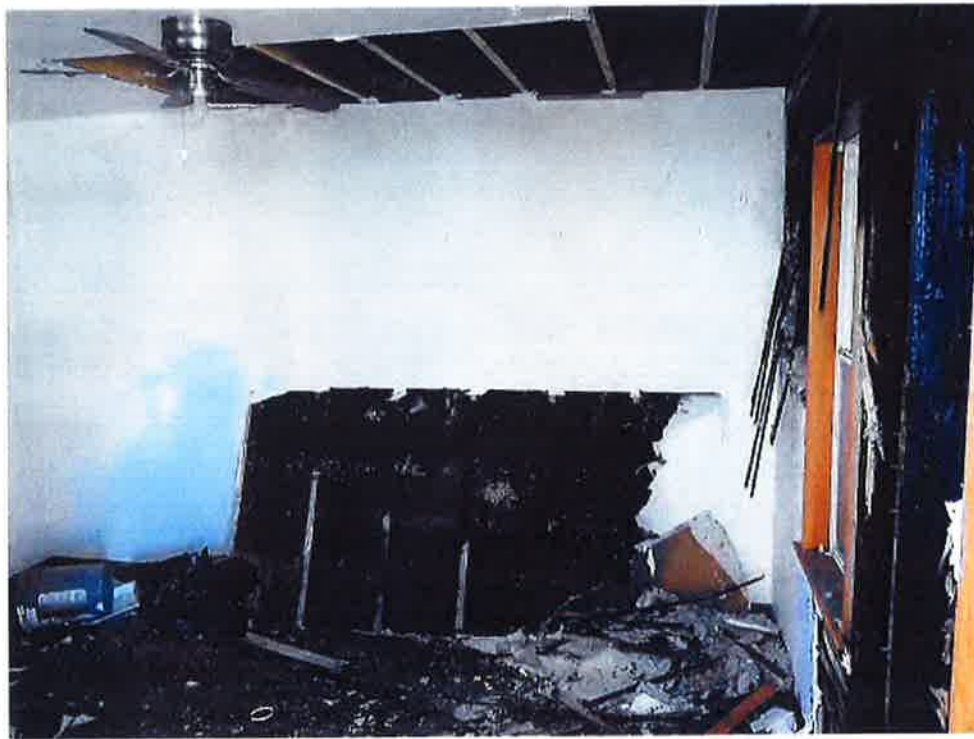
An interior examination of the structure showed evidence of a fire inside the east wall of the first floor living room. It was noted the room was dry walled and carpeted with a ceiling fan installed in the center of the room, yet none of those showed evidence of smoke staining, heat damage or burning.

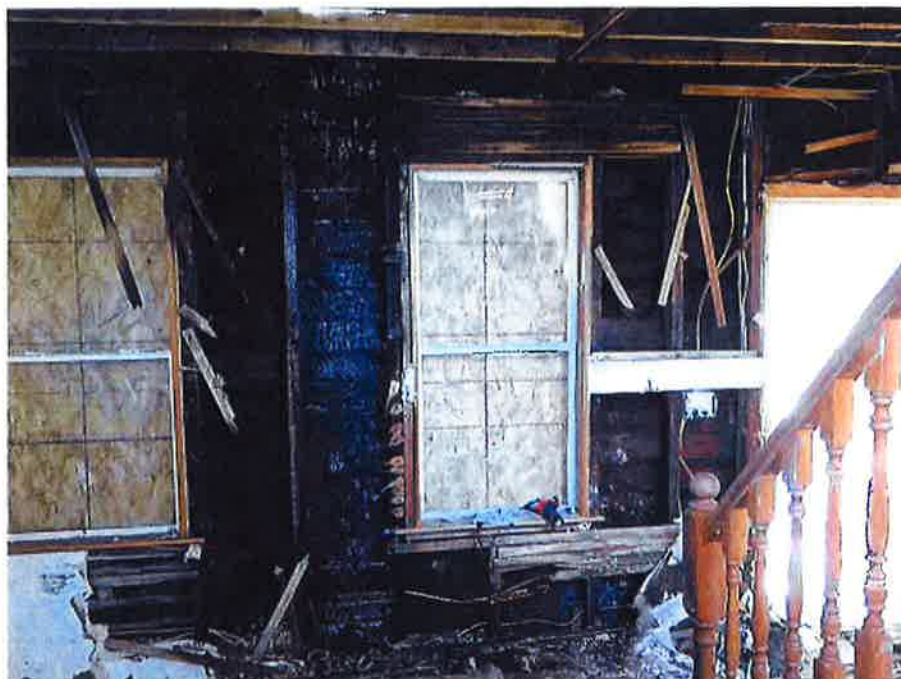
Living Room

The living room wall showed evidence of significant fire damage confined to one wall space between two wall studs. Damage appeared heaviest near ceiling level when compared to the remainder of the wall space.

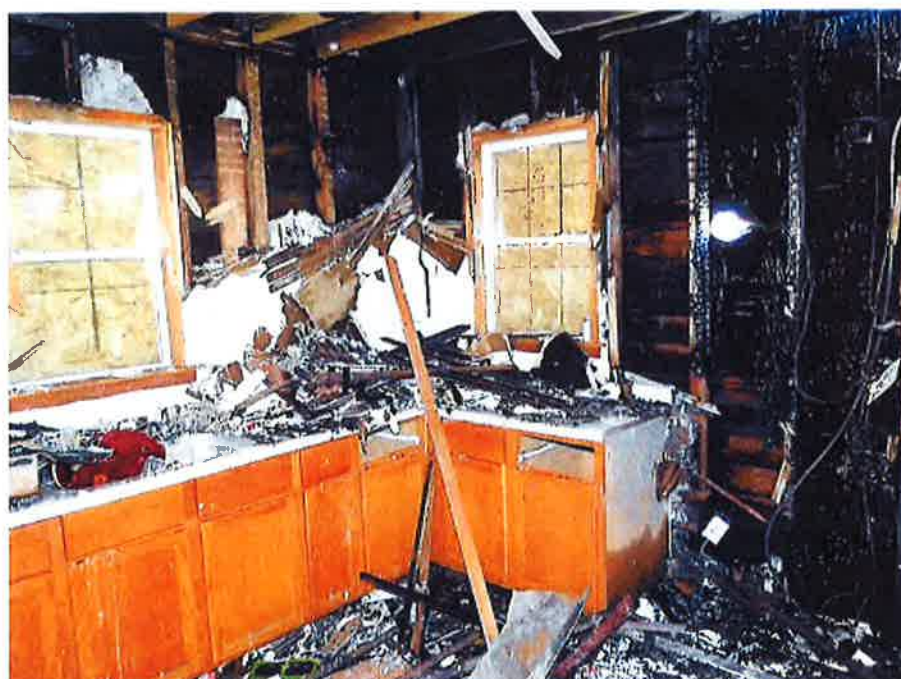
Kitchen

An examination of the kitchen and in particular the west wall, south of the back door, showed damage similar to the localized fire damage in the living room. The wall sustained heavy fire damage inside the wall, primarily between two wall studs like the living room. The drywall covered walls and kitchen cabinets did not show evidence of heat or fire damage, similar to the living room.

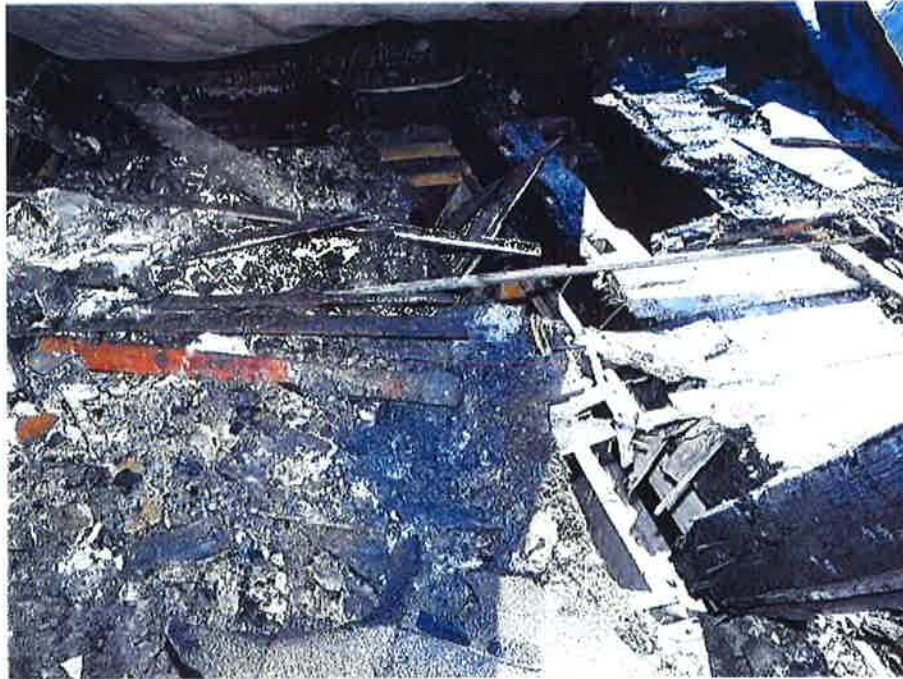
The first floor bathroom located along the south side of the residence near the center of the residence showed heavy fire damage above the bathroom ceiling that appeared to extend into the attic space but did not seem to communicate with the fires in the east or west walls.

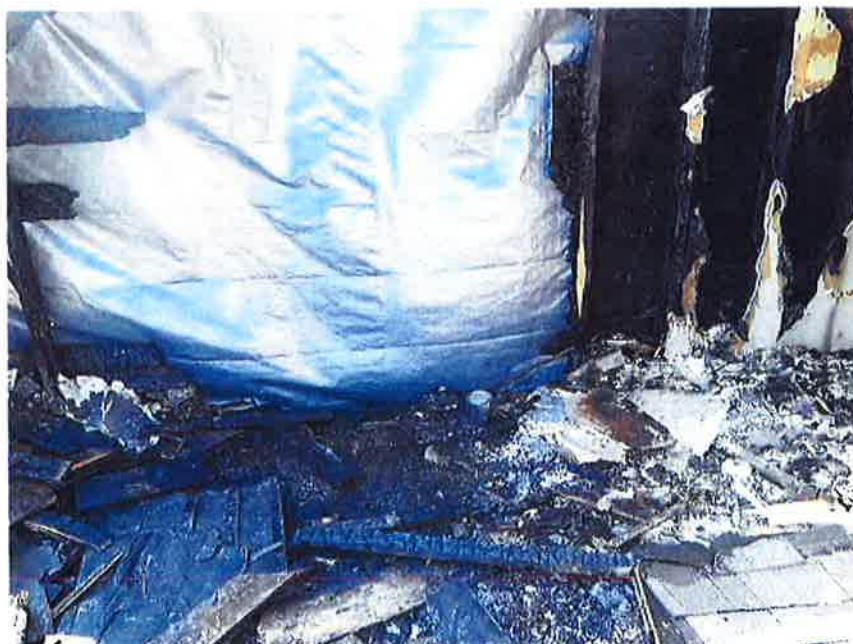
Second Floor Attic Space

Based upon Mr. Starr's observation, debris was excavated from the second floor attic space floor, directly above the area of the electrical arcing. When reaching floor level, carpet and padding were discovered that emitted an odor similar to gasoline.

On March 28, 2017, Great Lakes Analytical, Inc. authored a Laboratory Report stating gasoline was identified in the debris sample collected from the second floor location.

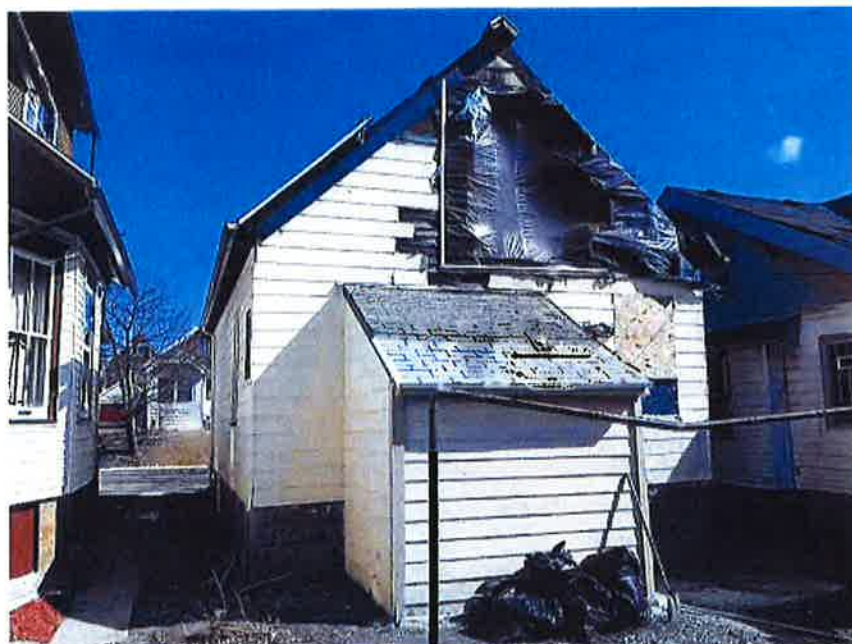
This area is consistent with where the residence suffered significant fire damage to the exterior of the residence.
